Article

## Wind Load Test of Earthbag Wall

**Abstract:** Earthbag construction is a sustainable, low-cost, housing option for developing countries. Earthbag structures are built of individual soil-filled fabric bags (*i.e.*, sand bags) stacked in a running bond pattern. Once stacked, earthbags are compacted and the soil inside the bags is dried in-place to form earthen bricks. Barbed wires are placed between each course to affect shear transfer within the wall. Results of an out-of-plane load test on a full-scale earthbag wall are presented in this paper. The wall was subjected to out-of-plane pressure up to 3.16 kPa, which resulted in plastic deformations up to 50 mm. The wall did not collapse during loading. Wall behavior and force transfer mechanisms are discussed.

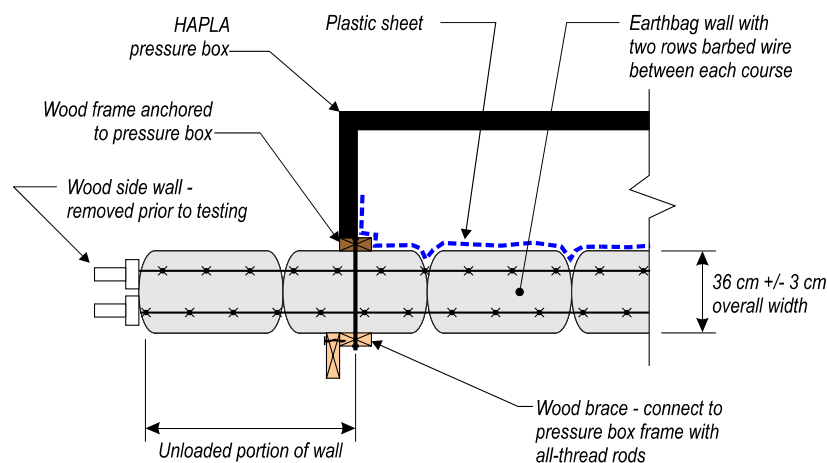
**Figure 1.** Elevation and details of earthbag test wall.

The test wall was approximately 229 cm tall by 366 cm long by 36 cm thick, and was built using 134 individual earthbags (Figure 1). Each bag contained approximately 0.45 kN of soil. Bags were stacked in a running bond pattern. After each course was placed, soil in the bags was compacted by multiple blows with a tamper (Figure 2). Outer dimensions of compacted bags were approximately 17 cm tall by 41 cm. long by 36 cm wide. Half-sized bags were used at the ends on every second course to form the running bond pattern. A wood side wall was framed at each end of the earthbag wall to restrain in-plane movement of the bags during compaction. The wood side wall was removed from the wall ends prior to testing.

#### Wall Elevation

#### Section A

#### Section B

The bags were made of 900 dtex polypropylene. Empty bags were approximately 46 cm by 76 cm. The bags were tubular in construction with the bottom sewn closed. During stacking, the top of the bags were folded under to prevent loss of soil during compaction and load testing. Two rows of galvanized barbed wire were placed between each course of bags. Each row of barbed wire consisted of two individual wires twisted together with four 1.3 cm long barbs spaced at 13 cm. Individual wires were 1.94 mm in diameter. The cross-sectional area of barbed wires between each course was 5.91 mm<sup>2</sup>.

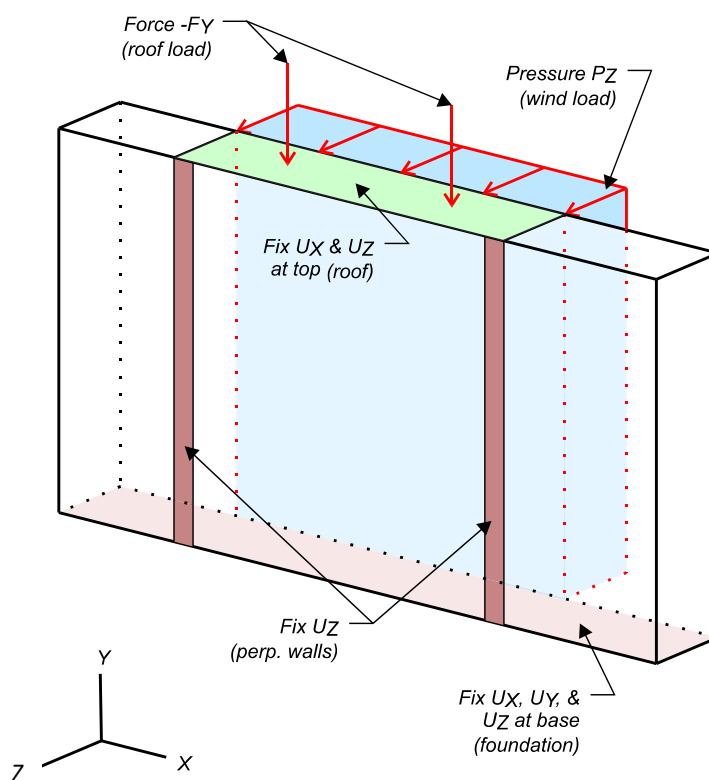
**Figure 3.** Test wall boundary and loading conditions.

Wall details were designed to create the boundary and load conditions shown in Figure 3. Translation at the base of the wall was restrained in the Z-direction by connection with the wood pedestal. The connection was accomplished by embedding screws protruding from the pedestal into the lowest course of bags. The screws were embedded 5 cm, and were spaced at 13 cm on center in two rows 13 cm apart.

Vertical wood braces were placed 244 cm apart on the front of the wall. Braces were placed flat and provided restraint against Z-direction (out-of-plane) translation, similar to restraint that would be provided by perpendicular walls in an earthbag dwelling. The braces were aligned with the edges of the HAPLA pressure box and were connected to the frame around the pressure box with threaded rods spaced at 61 cm.

A wood plate consisting of dimensional lumber and oriented strand board was used to simulate a bond beam at the top of the wall. The plate was connected to the top course using protruding screws

similar to the connection at the base of the wall. The top of the wall was detailed to allow free movement in the  $Y$ -direction (vertical), but restrain movement in the  $X$  and  $Z$  directions. This was accomplished by using slotted framing clips to attach the bond beam to the simulated rafters. The simulated rafters were attached to the pressure box using unslotted framing clips.

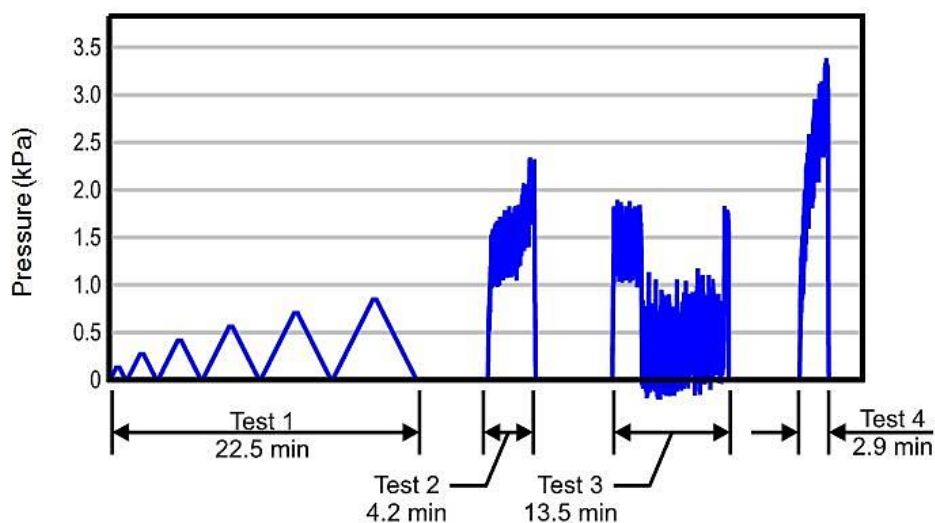
**Figure 4.** Pressure time history.

Four different stages of pressure loading were applied (Figure 4) within a two hour period. A series of ramped loads with increasing magnitude were applied during stage 1 to verify the safety of the wall at lower loads and to decide upon target pressures for the subsequent stages. Stages 2 and 4 were proof-load tests designed to evaluate wall behavior under static loading. Stage 3 included a dynamic

pressure time-history to evaluate wall behavior under simulated hurricane conditions. Pressures in stages 2–4 are of the magnitude expected during hurricane events.

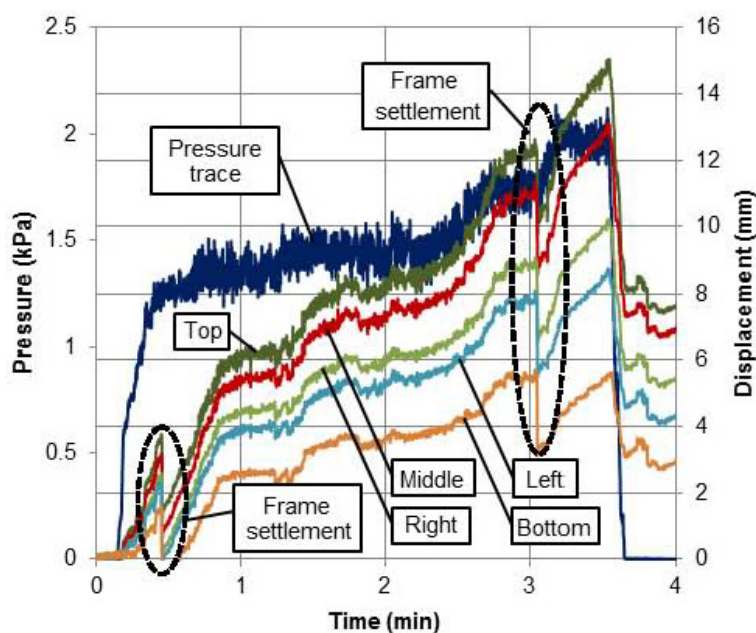
**Figure 6.** Test 2 displacement and pressure data. Sudden jumps in displacement occurred due to settlement of the instrumentation support frame.

Figure 6 shows the pressure and displacement history from test 2. Data from test 2 are representative of the behaviors and trends observed in the other tests. As previously noted, the frame holding the string potentiometers shifted multiple times during testing. The shift events are labeled in the Figure 6.

Displacement measurements taken by string potentiometers during the load tests were compromised by unintentional shifting of the wood frame that held the instruments (Figure 5). The shifting events appear as sudden drops in the displacement data (Figure 6) and made it impossible to determine absolute displacements from the potentiometer data. Relative displacement data from the potentiometers were still useful and are discussed in the next section. Frame shifting did not affect the measurements of the wall position taken by tape measure before and after testing.

The largest relative displacements were reported by the top potentiometer and the smallest were reported by the bottom potentiometer (Figures 5 and 6). This result was confirmed by visual observation (Figure 7) of wall deformation and is attributed to variation in friction forces throughout the wall. Friction forces were greatest at the bottom of the wall because self-weight axial force, and consequently friction force was proportional to the vertical distance from the top of the wall. Larger friction forces lower in the wall provided additional restraint and resulted in relative displacements that were smaller than those reported at the top of the wall. It is concluded that out-of-plane forces were in-part transferred vertically in the test wall through friction between bags.

Although the majority of wall displacements were plastic, the wall also exhibited partial elasticity when load was removed at the end of each test stage. This behavior can be observed in Figures 6 and 8, where displacement rebounded partially as load was removed. This behavior is attributed to elastic response of the barbed wire and possibly due to partial elastic response of the soil. Of these factors the barbed wire is thought to be more significant. During deconstruction it was observed that out-of-plane deformations were sufficient to pull the barbed wires taut, confirming that the barbed wires were engaged in tension during load testing and could have contributed to the observed elastic response.

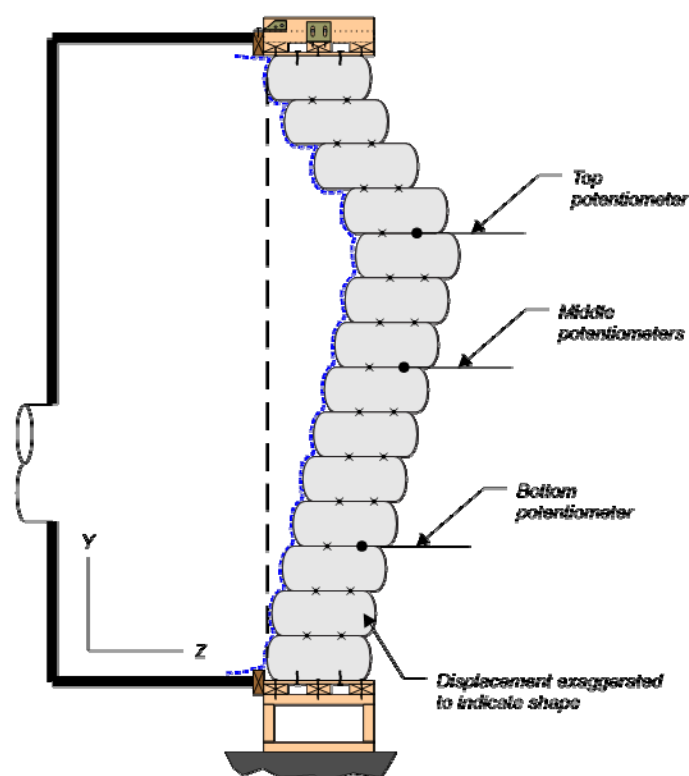
**Figure 7.** Exaggerated displacement of wall based on visual observations. The largest displacements occurred near the top potentiometer.

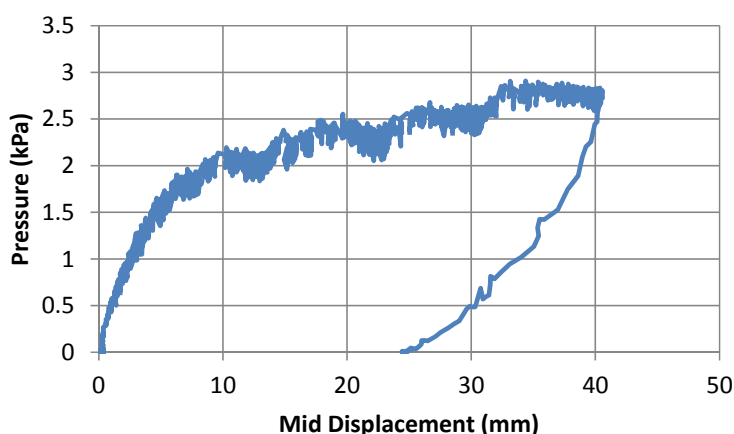
**Figure 8.** Pressure-displacement relationship at middle of wall for test 4.

to have been inconsequential on test results. Furthermore, inspection of the supports after the completion of testing did not indicate any significant permanent displacement of the supports. Displacement reported by the middle potentiometer during test 4 is shown in Figure 8. The figure shows the displacement relative to the beginning of test 4 and does not include plastic deformation from the previous tests. The frame supporting the potentiometers did not shift significantly during test 4. The pressure-displacement response was effectively linear until a pressure of approximately 1.6 kPa when the wall began to displace plastically. A similar result was observed in test 2, where plastic deformation was reported beginning at approximately 1.4 kPa. In both cases, displacement at the onset of plastic behavior was approximately 5 mm. This displacement is equal to the wall height divided by 45. Wall height divided by 180 is often used as a threshold for acceptable wall displacements. For the test wall, a displacement of 1.3 mm and a pressure of 0.5 kPa correspond to this threshold. Greater stiffness would be expected in walls finished with plaster rendering. The majority of deformations due to loading were plastic. Figure 9 shows the wall during deconstruction. At the time of the picture the top half of the wall had been removed. Permanent deformation due to loading was approximately 50 mm at the centerline of the wall at mid-height. Combined with the unintentional eccentricity built into the wall, the final position of the wall at the location shown was approximately 90 mm out-of-plane.

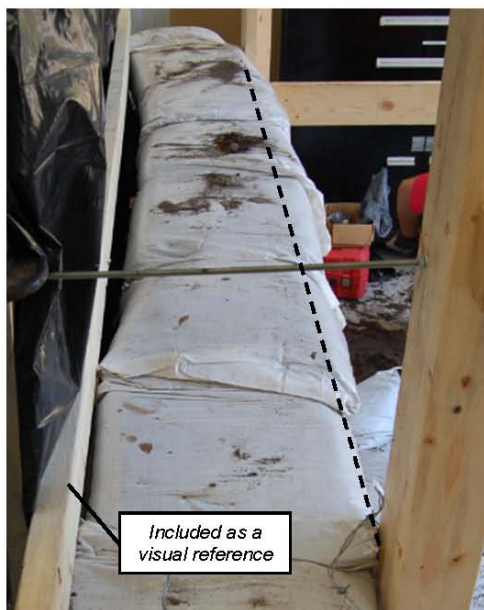
**Figure 9.** Permanent wall displacement as observed during wall deconstruction.

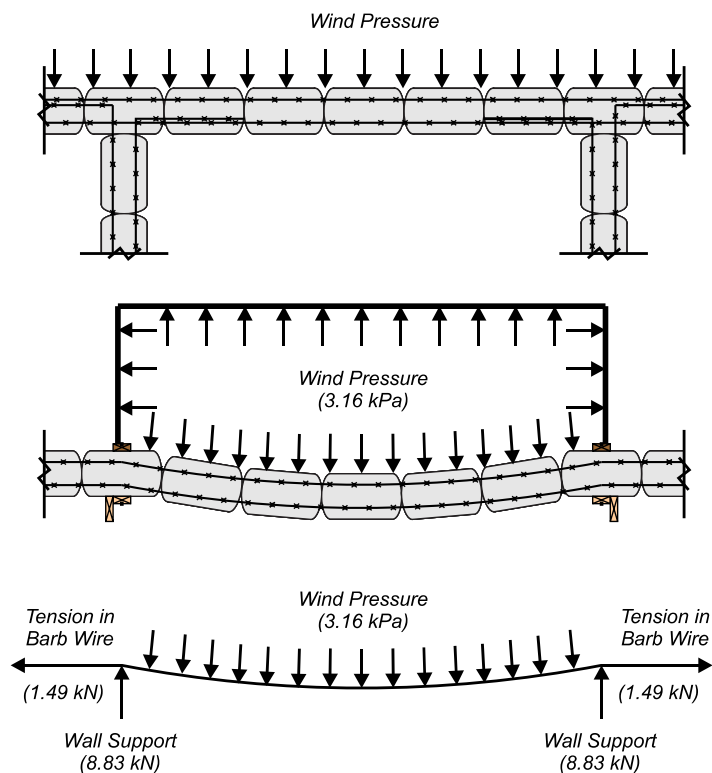
The effect of barbed wire tension is described conceptually in Figure 10. Forces were carried horizontally through the wall by the tension in the wires. Reactions at the end of the wires were supported in the *X*-direction by pull-out resistance of the wires embedded in the wall extensions beyond the pressure box and in the *Z*-direction by the wood braces placed in front of the wall.

**Figure 10.** Plan view of earthbag structure (**top**); plan view of test wall (**middle**); estimated forces in barbed wire and wall supports at peak pressure (**bottom**).

The tension force in the wires was estimated using an analogy to pressure vessel theory, and by assuming that the wires were deformed into a roughly circular shape with a radius of curvature of approximately 825 cm. Both assumptions are reasonable considering the wall geometry, measured wall deformations, and observed deformed shape (Figure 9). For the pressure vessel analogy the barbed wires carried circumferential tension forces similar to a vessel wall, and internal pressure was equal to the wind pressure applied by the HAPLA system. Force transfer via friction was neglected. Accordingly, the estimated tension in the wires at peak load was 1.491 kN (504 MPa). The in-plane component of the tension force was reacted by the pull-out capacity of the wires in the wall extensions. Based on pull-out test results by Stouter [17] the anchorage provided by the wall beyond the wood braces was sufficient to develop the calculated force.

These calculations highlight the importance of barbed wire and of out-of-plane bracing in earthbag structures. The barbed wire transferred forces through tensile action, which was restrained in the out-of-plane direction by the wood braces. Had the braces been spaced further apart, the barbed wire, and consequently the wall, would have displaced a greater amount to achieve the same load carrying capacity. Greater displacements may have resulted in collapse of the wall prior to engagement of the barbed wire. Accordingly, results of the wall test are not applicable to walls with perpendicular supports spaced farther than 244 cm apart. Until additional information is available, it is recommended that earthbag walls with similar aspect ratios to the test wall be built with perpendicular supports spaced no greater than 244 cm.
